**EVALUATION OF EDGE DRAINS
ON I-81, IN ROANOKE, VIRGINIA**

Research Report
KTC-96-12

June 1996

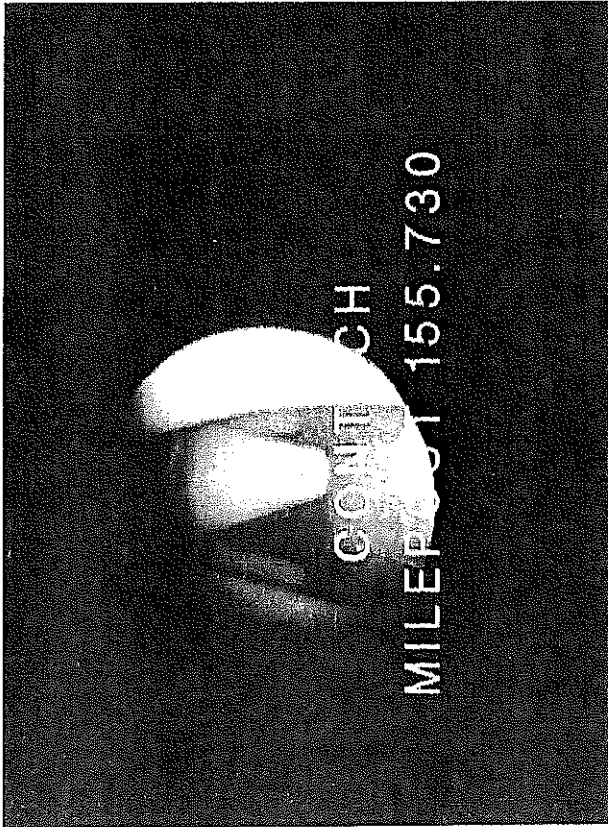
Fabric Intrusion, Mid Panel

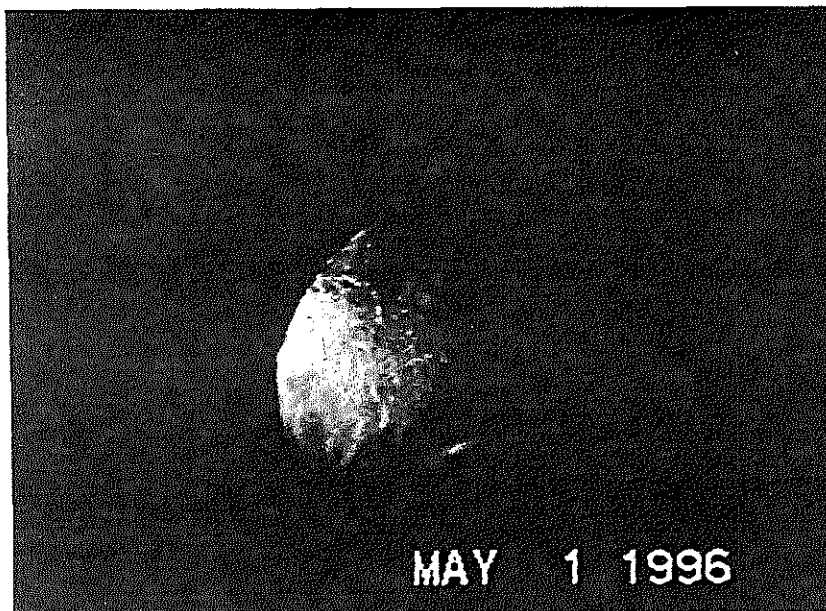
Tilting of Columns, Bottom Panel

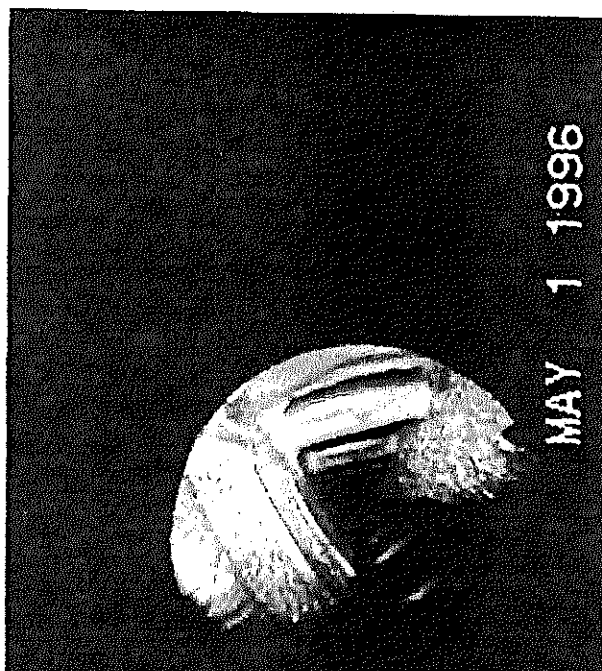
Rolling of Columns, Fabric Intrusion, Bottom

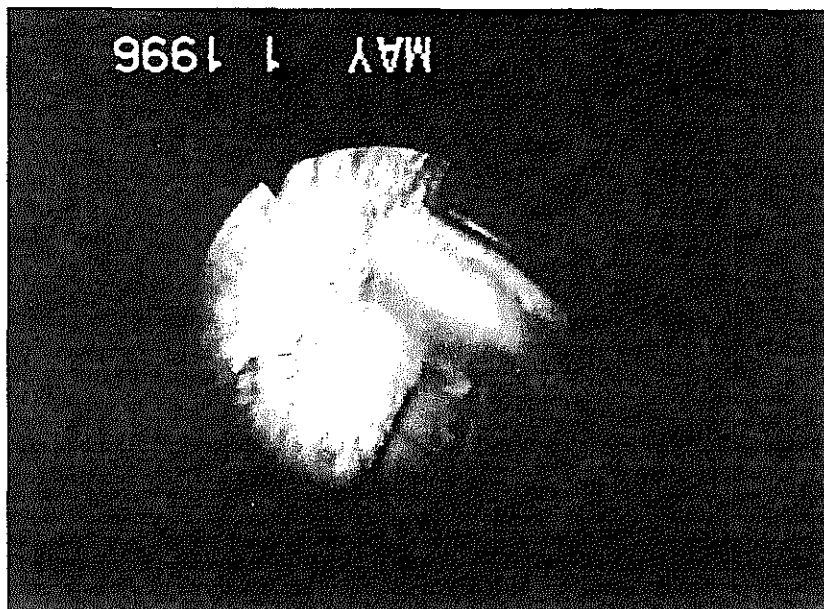
Rolling of Columns, Fabric Intrusion, Bottom
